Paradise Avenue Gatehouse, Spring Grove

Maryland Historical Trust State Historic Sites Inventory Form

Survey No. BA-2324

historic Paradise Avenue Gatehouse

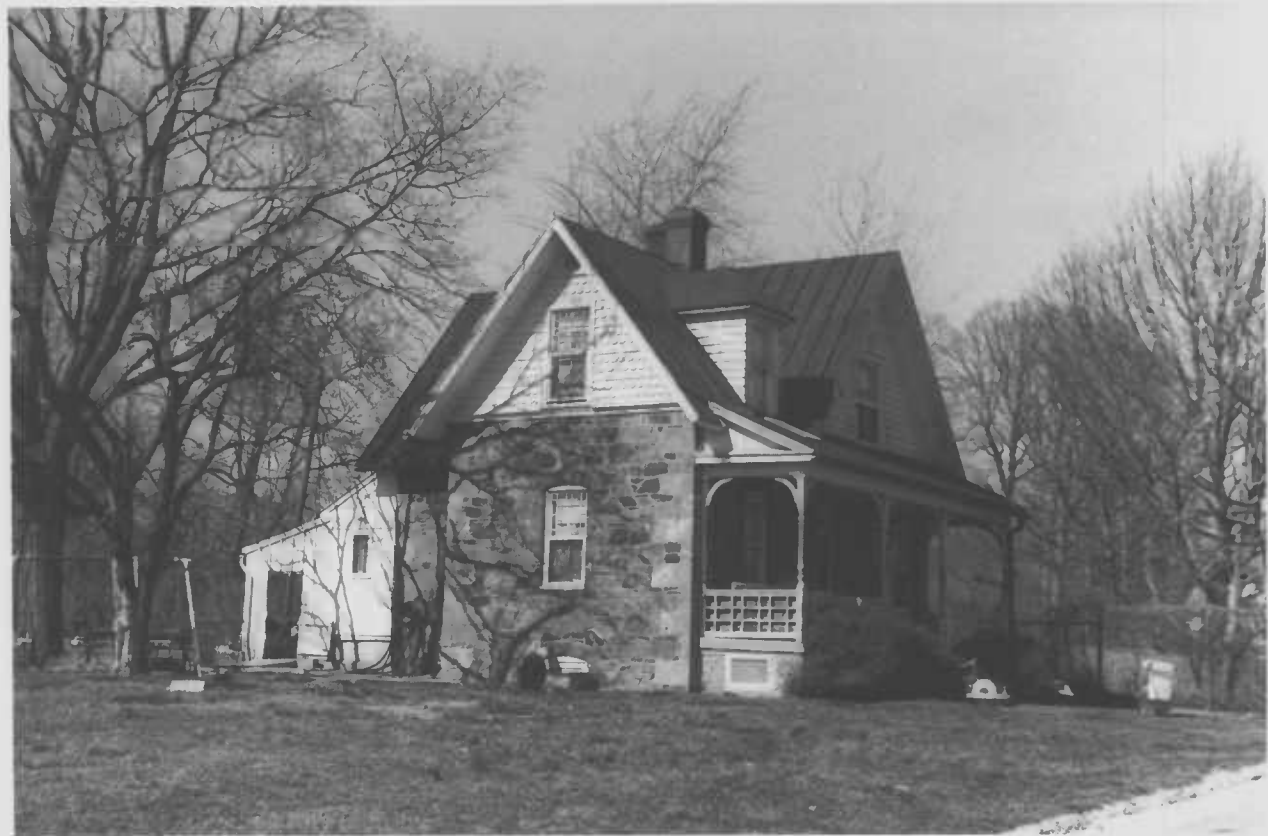
BA - 2324

PARADISE AVENUE GATEHOUSE
SPRING GROVE HOSPITAL CENTER
CATONSVILLE, MARYLAND
SOUTH AND EAST WALLS
DON JEWELL, 4/86
NEGATIVES AT MHT

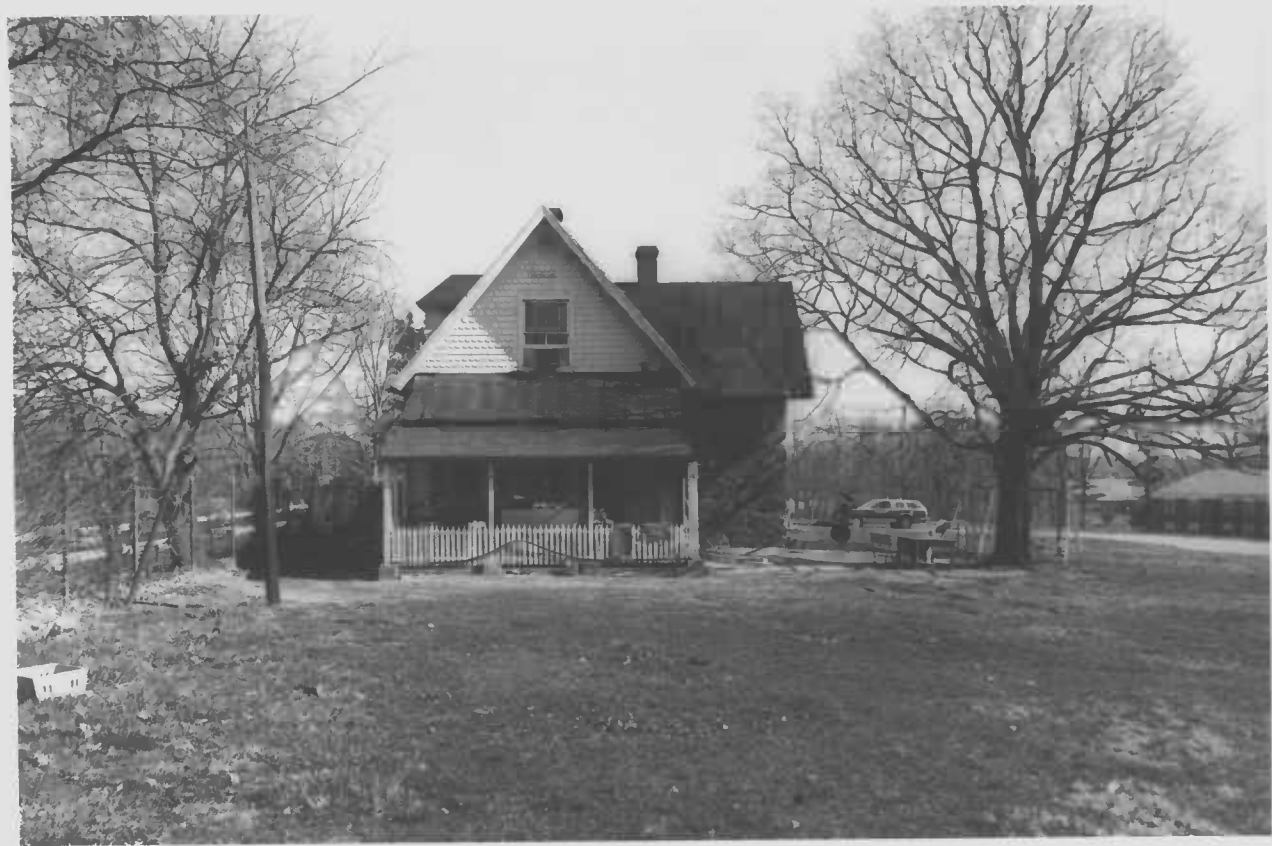
BA- 2324

WEST WALL
